USING ADVANCED LAB TESTING TO ADDRESS SOME COMMON GEORISKS IN UAE

Dr MAN BUI AND ENG. EMAD SHARIF

DFI GEOTECHNICAL SUMMIT, THE BIG 5 GLOBAL 2022 5th December 2022, 16:30– 16:50 Sheikh Saeed Hall 2, Theatre 2 – Dubai World Trade Centre

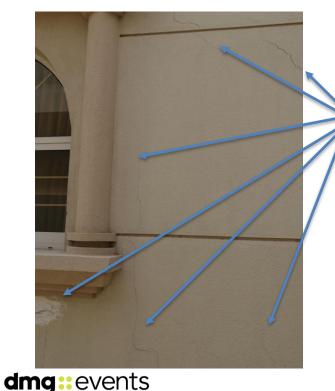
Example of wall cracks of a private villa supported by shallow foundations on sand at al Warga, Dubai

Various serve cracks from front wall, back wall, sidewalls, first floor, second floors with various crack directions, led to high cost for remediation

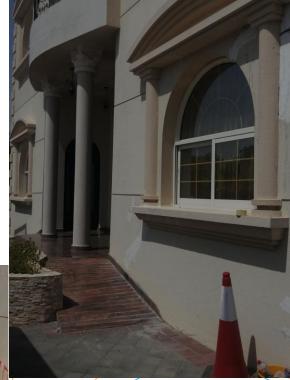
THE SAND BENEATH THE FOUNDATION

- No GWT encountered in trial pits to 2.0m BGL
- Relatively higher water content at TP2 (5%-8%) increasing with depth.
- Water pipe line was previously broken and repaired, as clarified by the owner.
- ➔ Softened soil, reduction in soil shear strength and stiffness.

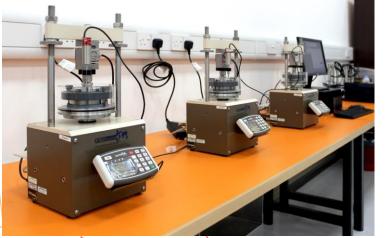
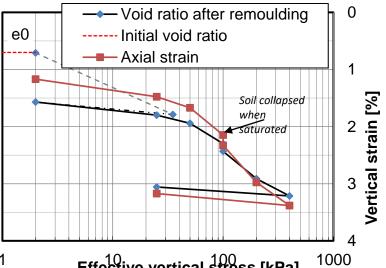
MEASUREMENT OF COLLAPSIBLE INDEX

MODERN 1D CONSOLIDATION SYSTEM WITH TAYLORED TESTING PROCEDURE

Void ratio after remoulding 0 e0 Initial void ratio Axial strain Vertical strain [%] Soil collapsed Void ratio when saturated 3 Effective vertical stress [kPa] 1000

- **SLIGHTLY COLLAPSE INDEX (0.42%)**
- => Confirmation of the Different settlement e.g. of 12mm for a • layer of 3m (2 time the foundation width) thickness of calcareous sand

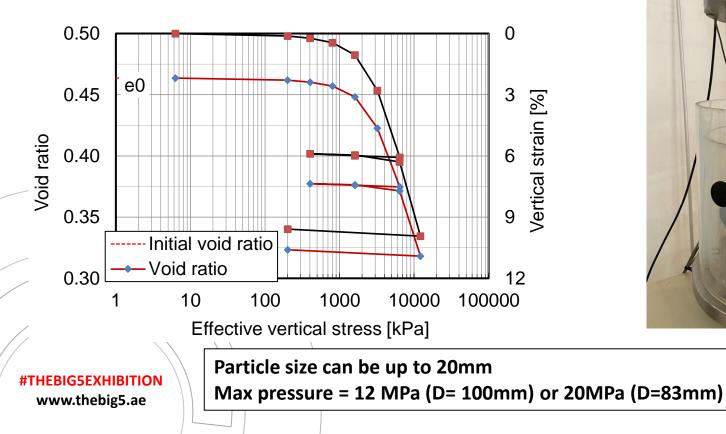
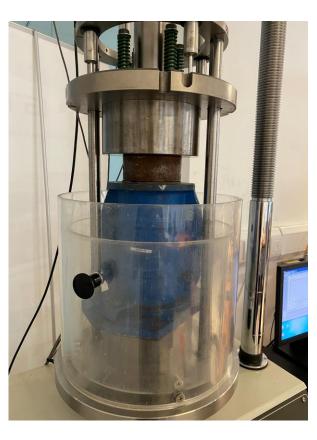
Large scale oedometer tests

To remove the effect of particle size, and high pressure applied

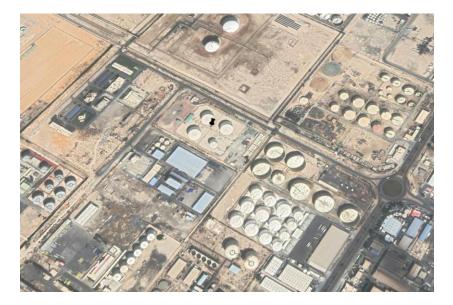
EXCESSIVE PERMANENT SETTLEMENT AFTER LONG TERM CYCLIC LOADS

ESPECIALLY FOR OIL AND GAS FACILITIES

- The process of filling and emptying of the tank has caused the major settlement accumulated with time, observed for both dense calcareous sand and very dense granular engineering fill.
- It is likely that no further settlement taken place in the granular fill and in calcareous sand after 75 and 95 loading cycles, respectively, thanks to the stiffening effects in fully drained condition under cyclic load.
- Creep could partially contribute to the settlement but not represent the actual loading mode of the tanks, and Creep underestimated the long-term settlement of the tank.

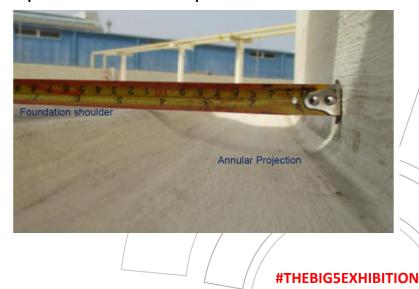
Different settlements beneath tank bottom annulus after 10-year operation exceeded acceptable limited as per API standard.

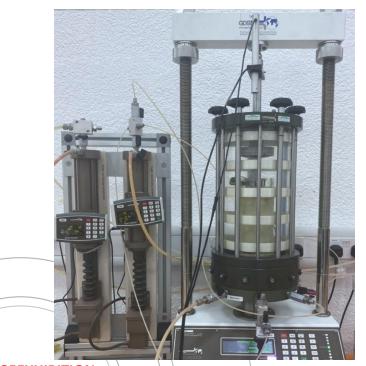
CREEP TEST IN TRIAXIAL CELL

BENEFIT OF LARGE SAMPLE SIZE & STRESS HISTORY SIMULATION

Stage	For g fi	ranular ll	For calcareous sand					
	s' _r (kPa)	s' (kPa)	s' _r (kPa)	s' (kPa)				
Overburden pressure	45	45	145	145				
Superstructure	45	75	145	175				
Hydrostatic test loading	45	265*	145	345 *				
Hydrostatic test unloading	45	75	145	175				
* Note: the summation of the hydrostatic test

* Note: the summation of the hydrostatic test pressure, dead weight of the tank

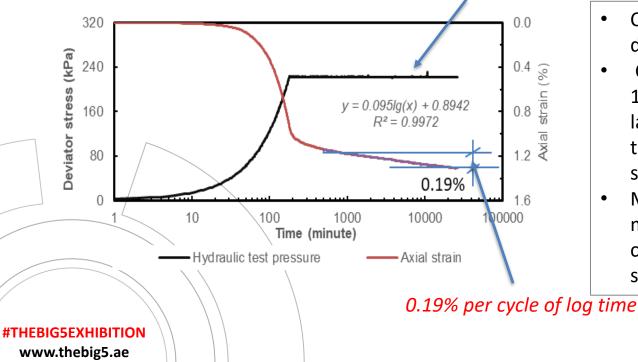
Creep Test Results

Hydraulic-test load of 190 kPa > 170 kPa Oil pressure

- Creep monitored until almost deformation ceased.
- Creep could contribute up to 19 mm settlement for a 10 m layer of sand in the field << than the measurement settlement
- Meaning the Creep settlement may not be the major factor causing the excessive settlement of the tank.

• The creep rate of dense calcareous sand measured in the laboratory under effective stress of 190 kPa, was 0.19% per logarithmic time cycle, which exceeds the estimates made by empirical relations for 10 years period, whereas residual vertical strain resulted from cyclic loading and unloading is much higher.

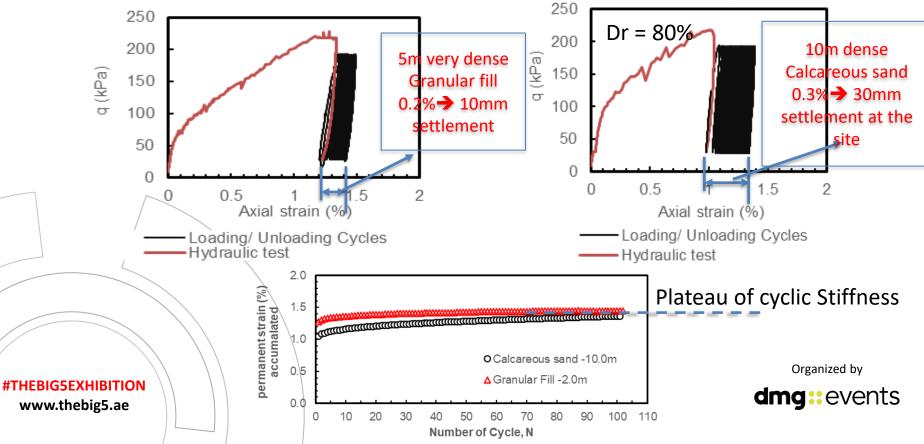
Simulation of the oil Tank operation in 10 Years

Using very Low frequency cyclic Triaxial tests in drained condition for both calcareous sand and granular fill

Some remarks from the laboratory simulation of oil tank

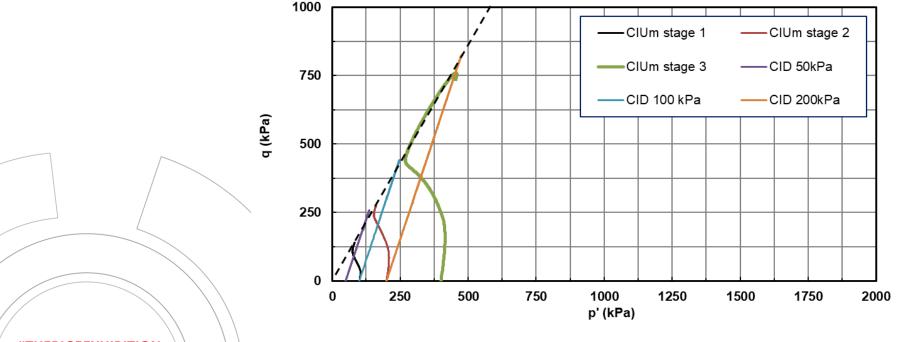
Uncertainties In Measurement of c & ϕ for Sand & Soft Rock

Multiple stage triaxial test, set of three CID tests

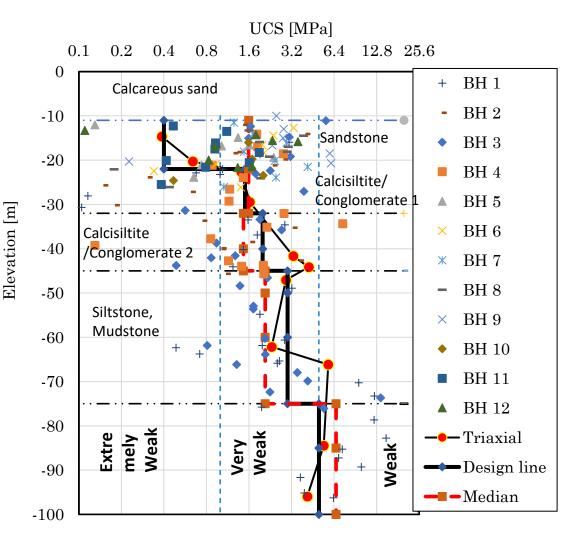
PILE BEARING CAPACITY AND SETTLEMENT

Uncertainties in UCS Test Results will affect the design of Bored pile For Highrise Building

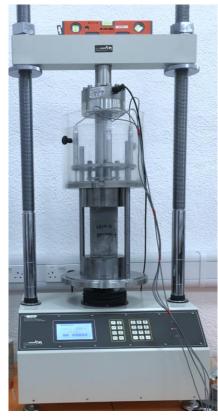
Reduce uncertainties in UCS Test

Testing procedure & specimen conformity assessment

sample	L/D	Bulk Density (g/cc)	Dry Density (g/cc)	Moisture content (%)	UCS (MPa)	e50	E50	
		(8/00)	(g/cc)	(/0)		(%)	(MPa)	
No #8	2.03	2.03	1.84	10.2	9.43	0.13	3682	
No #1	2.03	2.03	1.85	10.0	9.12	0.13	3626	
No #3	2.03	2.04	1.86	9.6	9.11	0.13	3439	
No #6	2.02	2.03	1.86	9.5	9.70	0.13	3690	
No #4	2.04	2.03	1.84	10.7	9.56	0.10	4935

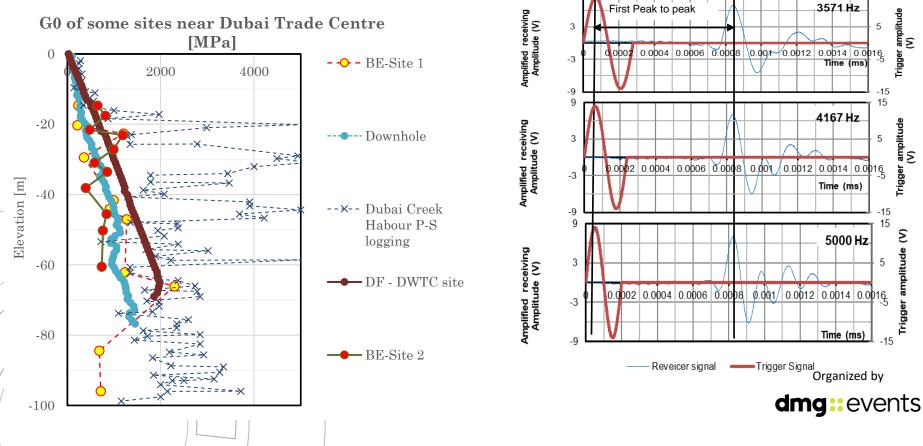
CONSISTENCY IN BENDER ELEMENT TEST

REDUCE UNCERTAINTIES IN GEOPHYSICS SURVEYS
